1. Scope

This document specifies the cable assembly procedures of crimping the crimp contact to the cable (AWG#24 to 28) and inserting the contact to the crimp socket for DF61Y Series.

COUNT	DESCRIPTION OF REVISIONS	DESIGNED	CHECKED	DATE
△					
TITLE			HRS HIROSE ELECTRIC CO., LTD.		
DF61Y Series Cable Assembly Procedure			APPROVED	TS. FUKUSHIMA	18. 04. 20
			CHECKED	TS. FUKUSHIMA	18. 04. 20
			DESIGNED	TS. KUMAZAWA	18. 04. 20
			WRITTEN	SN. MIWA	18. 04. 20
TECHICAL SPECIFICATION			ETAD-H0833-00		△ 1 / 2

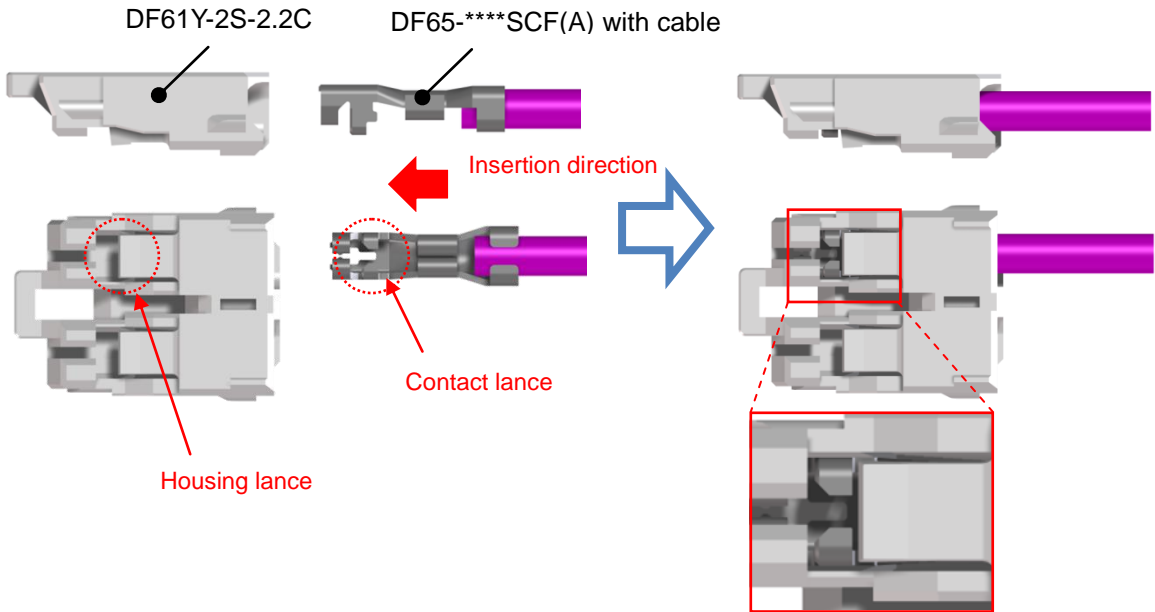
Hold the cable of crimped contact and insert to each contact cavity of the crimp socket. (Insertion direction is as shown below.)

Make sure that the contact lance is hooked by the housing lance of the crimp socket.

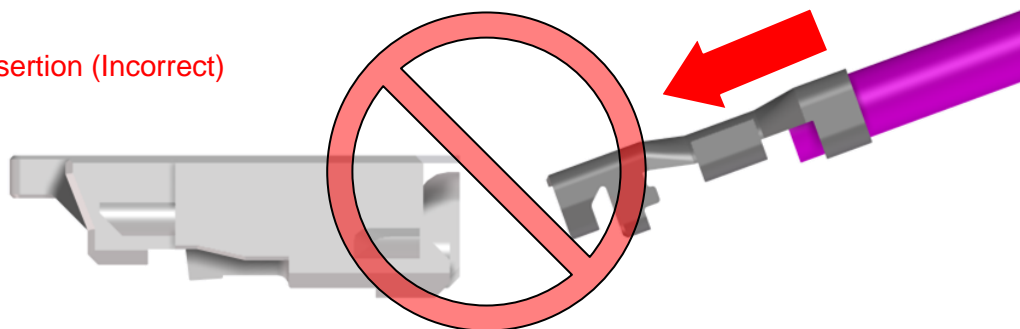
Angled insertion (Incorrect)

- Do not insert the crimped contact (DF65-****SCF(A)) at an angle to the socket in order to avoid unexpected damage.
Also, there is some deformation risk of crimped contact lance in case contact is wrenched at "not fully inserted" (to crimp socket) state.

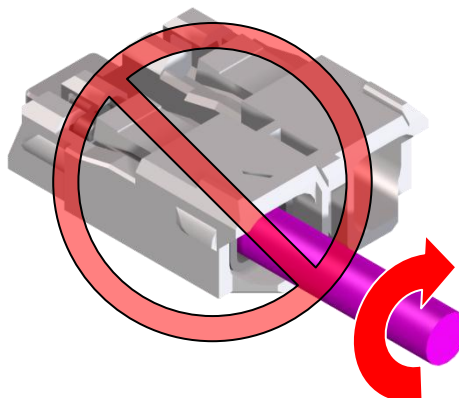
Twisted insertion (incorrect)

- After crimped contact insertion, please don't twist a cable excessively.

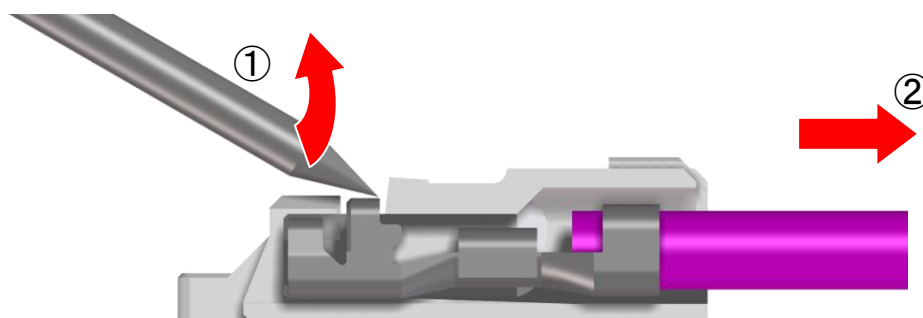
NOTE: Repairing the crimp contact

For removing the inserted contact from socket, lift up the housing lance by using DF-C-PO(B) or a pointed needle, and pull out the cable simultaneously. The repair operation could make the lance strength lower, therefore, please do not reuse the repaired crimp socket and replace it to a new one.
