1. Scope

This document specifies the cable assembly procedures of crimping the crimp contact to the cable (AWG#24 to 28) and inserting the contact to the crimp socket for DF61Y Series.

COUNT	DESCRIPTION OF REVISIONS	DESIGNED	CHECKED	DATE
△				
TITLE		HIROSE ELECTRIC CO., LTD.		
DF61Y Series Cable Assembly Procedure		APPROVED	TS. FUKUSHIMA	18. 04. 20
		CHECKED	TS. FUKUSHIMA	18. 04. 20
		DESIGNED	TS. KUMAZAWA	18. 04. 20
		WRITTEN	SN. MIWA	18. 04. 20
TECHICAL SPECIFICATION		ETAD-H0833-00		△ 1 / 2

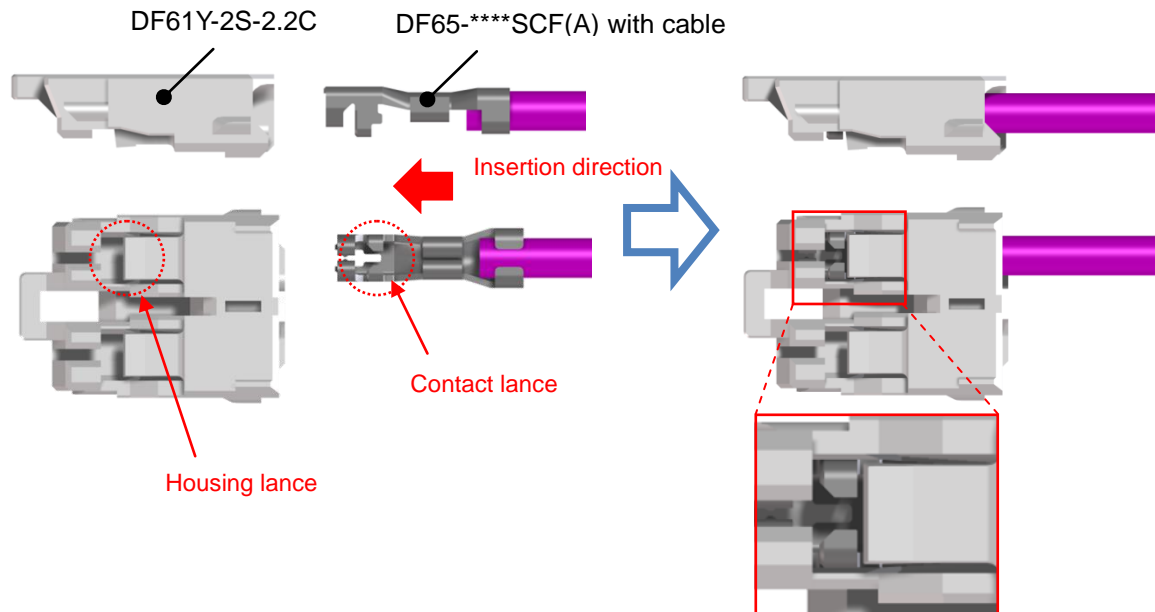
Hold the cable of crimped contact and insert to each contact cavity of the crimp socket. (Insertion direction is as shown below.)

Make sure that the contact lance is hooked by the housing lance of the crimp socket.

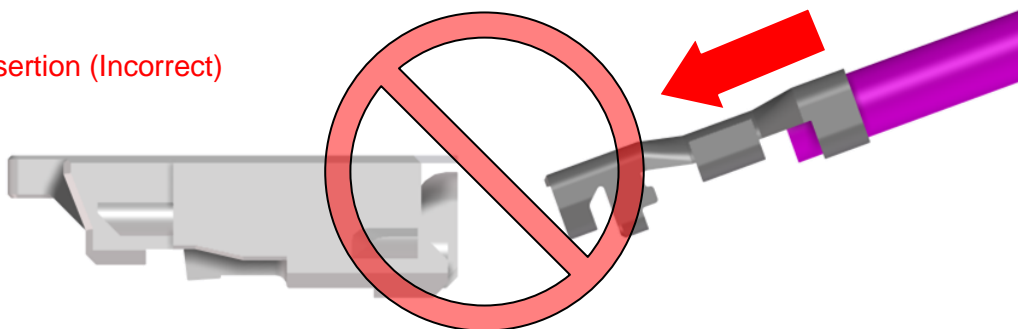
- Do not insert the crimped contact (DF65-****SCF(A)) at an angle to the socket in order to avoid unexpected damage.
Also, there is some deformation risk of crimped contact lance in case contact is wrenched at “not fully inserted” (to crimp socket) state.

Angled insertion (Incorrect)

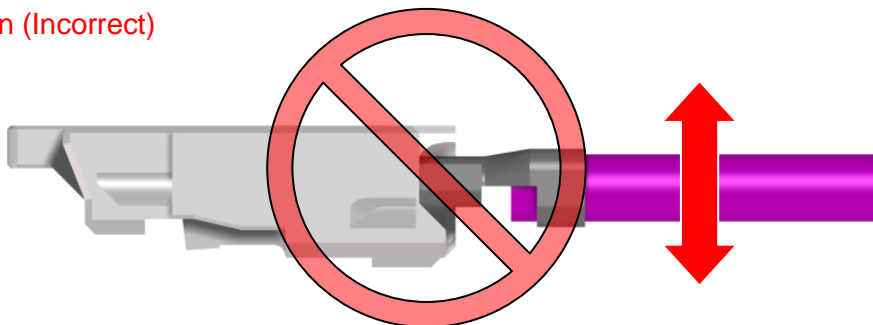
Scoop insertion (Incorrect)

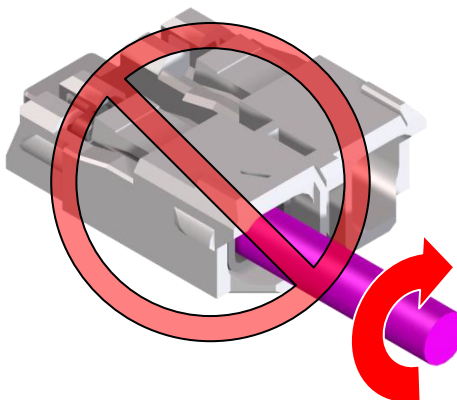
- After crimped contact insertion, please don't twist a cable excessively.

Twisted insertion (incorrect)

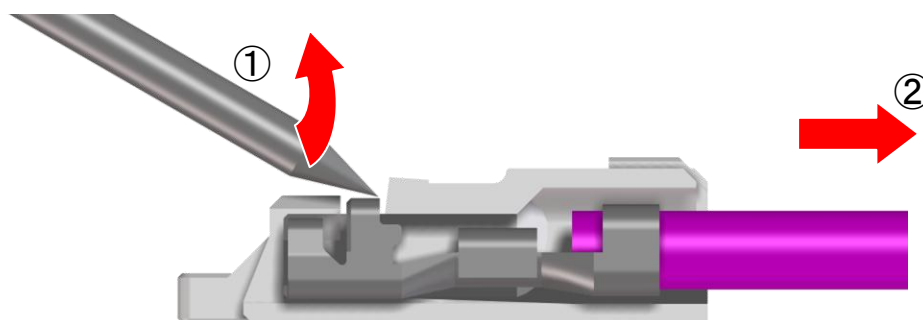
NOTE: Repairing the crimp contact

For removing the inserted contact form socket, lift up the housing lance by using DF-C-PO(B) or a pointed needle, and pull out the cable simultaneously. The repair operation could make the lance strength lower, therefore, please do not reuse the repaired crimp socket and replace it to a new one.
