| HIROSE ELECTRIC CO., LTD. | APPROVED | : HS. OKAWA | 20130313 | DRAWING NO. | | EDC3-347265-00 | |
| | CHECED | : KI. HIROKAWA | 20130312 | PART NO. | | FX30B-3P-3. 81DSA30 | |

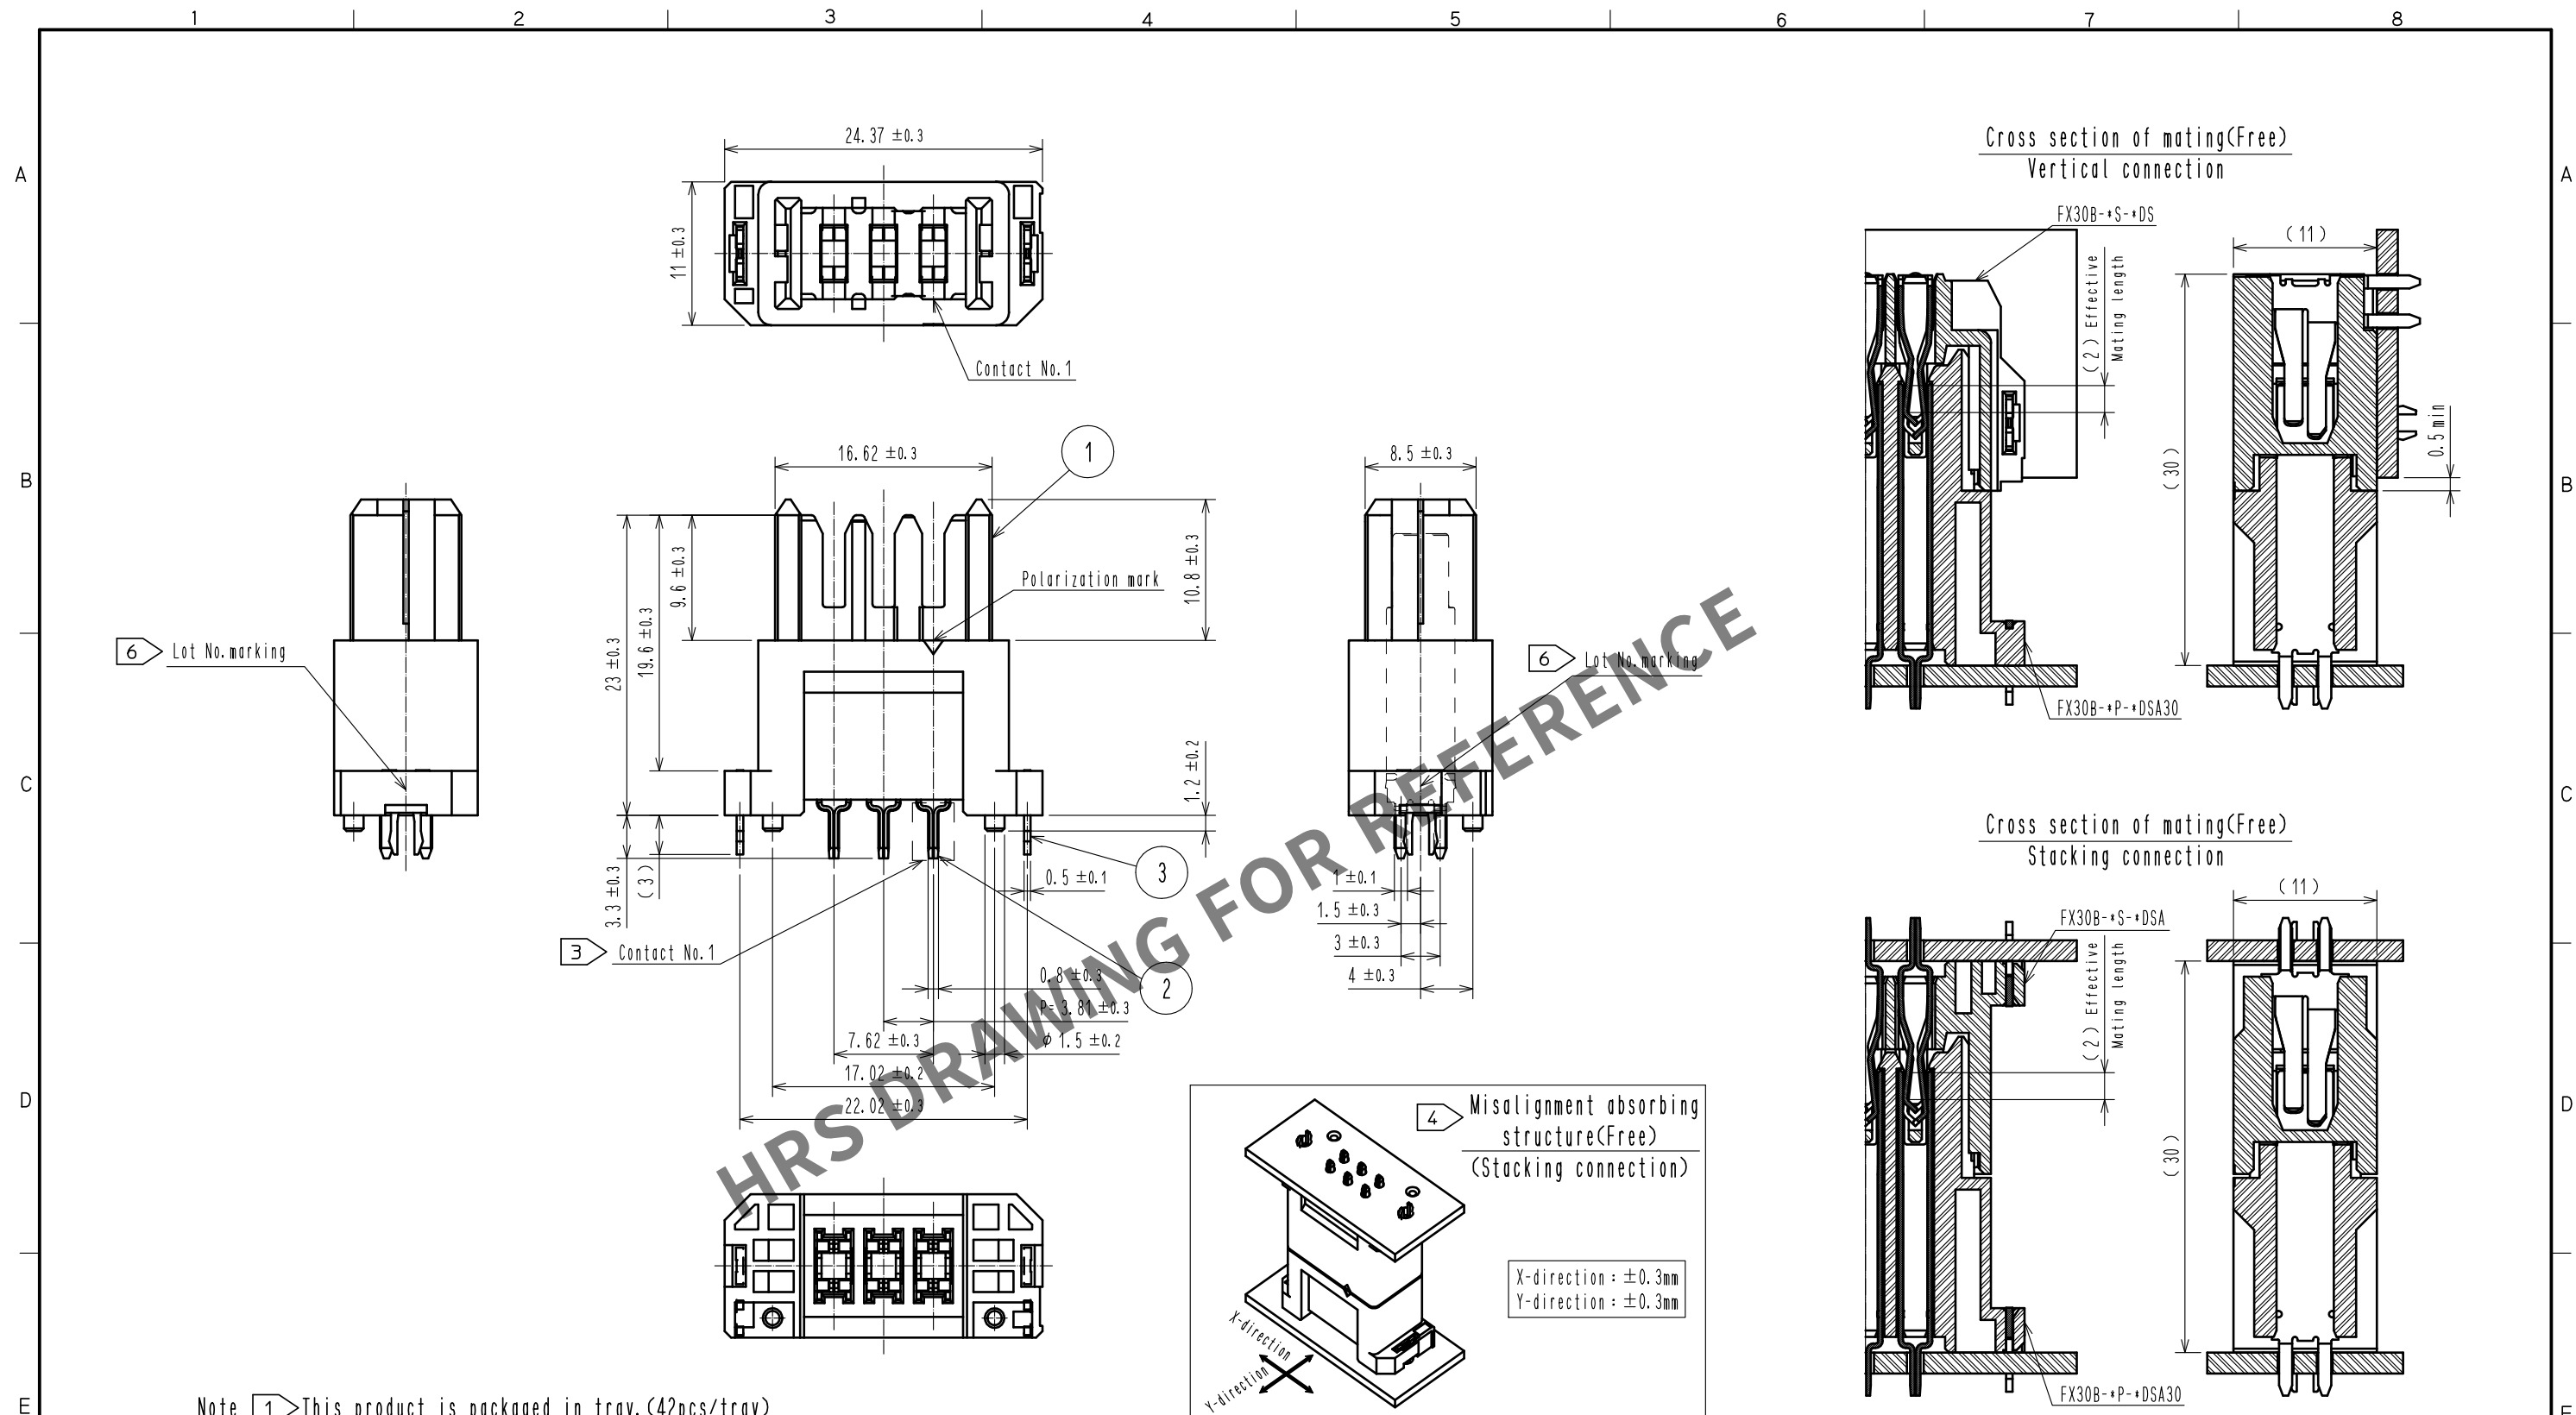
- ① This product is packaged in tray. (42pcs/tray)
- ② Blemish and hit mark can be occurred through out the manufacturing process which doesn't affect quality level.  
Also, black spot could be observed on the surface of housing.
- ③ For the contact No., adjacent two pairs of leads placed back-to-back (4 leads in total) compose one line.
- ④ Misalignment absorbing range:  $\pm 0.3\text{mm}$  max.
- ⑤ The dimension in parentheses are for references.
- ⑥ Lot No. is indicated at either one of the position as shown.

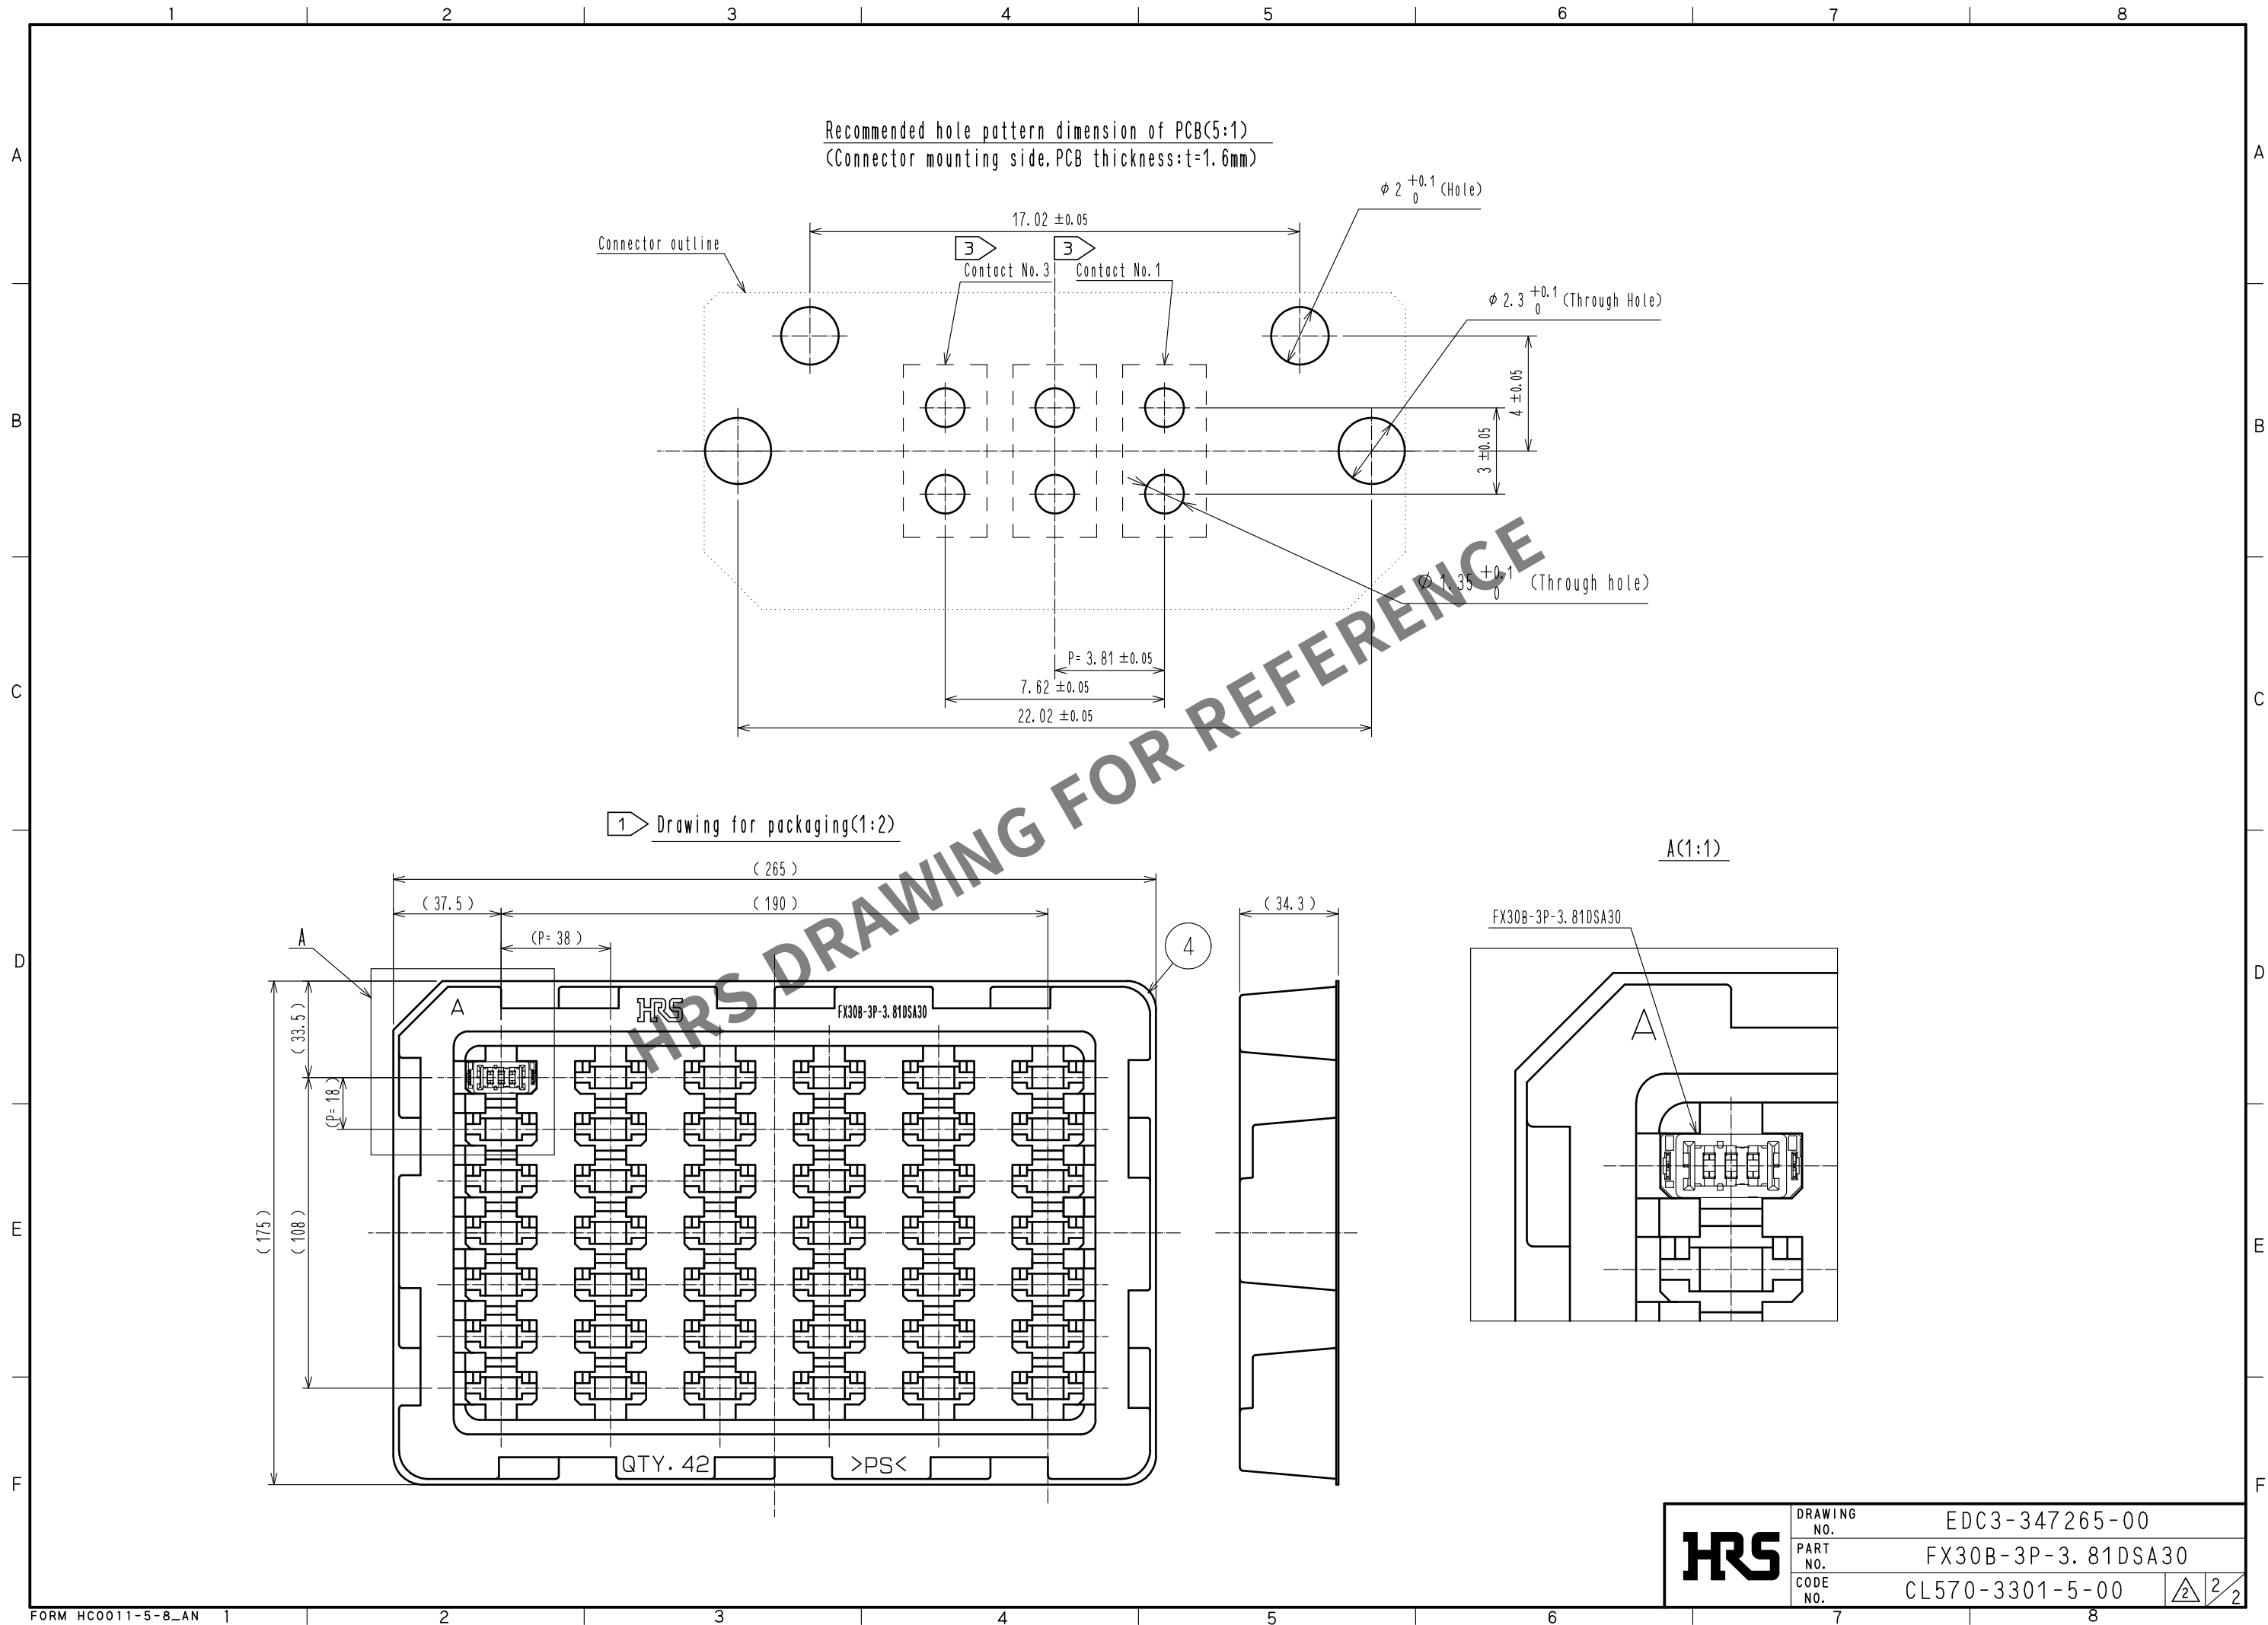
| 2 | COPPER ALLOY | CONTACT AREA:GOLD-PLATING 0.1 μm | | 4 | POLYSTYRENE | | |
| | | LEAD AREA:TIN-PLATING 1.0 μm | | | | | |
| 1 | POLYAMIDE | UNDER PLATING:NICKEL 1.0 μm | | 3 | PHOSPHOR BRONZE | TIN-PLATING 3.0 μm | |
| | | BLACK UL94V-0 | | | | UNDER PLATING:NICKEL 1.0 μm | |
